Case study of landslide in the Karviná region using resistivity tomography measurements

The paper deals with the slide of Doubrava Vrchovec that occurs in district of Karviná in Doubrava Village. The slope deformation in this area was reactivated by mining effects and by precipitation. The studied area is the Ostrava-Karviná coalfield, situated in the Northeast of the Czech Republic. Objective area is situated in efficient distance of mining activity of both mining fields. Great movements temporally correlate with mining of most thick seams of Mine Doubrava and Mine CSA. Archive materials, basic data, aerial photographs of slope deformation were studied and evaluated at the beginning of the research. Moreover, engineering-geological mapping were performed, on the basis of which all landslide manifestations, such as starting scar, transport zone, accumulation area, cracks, sliding blocks, side banks, layer outcrops, hydrogeological structures (for example, wells, wetlands, springs, line of springs). Resistivity tomography measurements (geophysical method of multielectrode resistivity measurement) were taken. On the basis of the carried out exploration work, it can be said that the

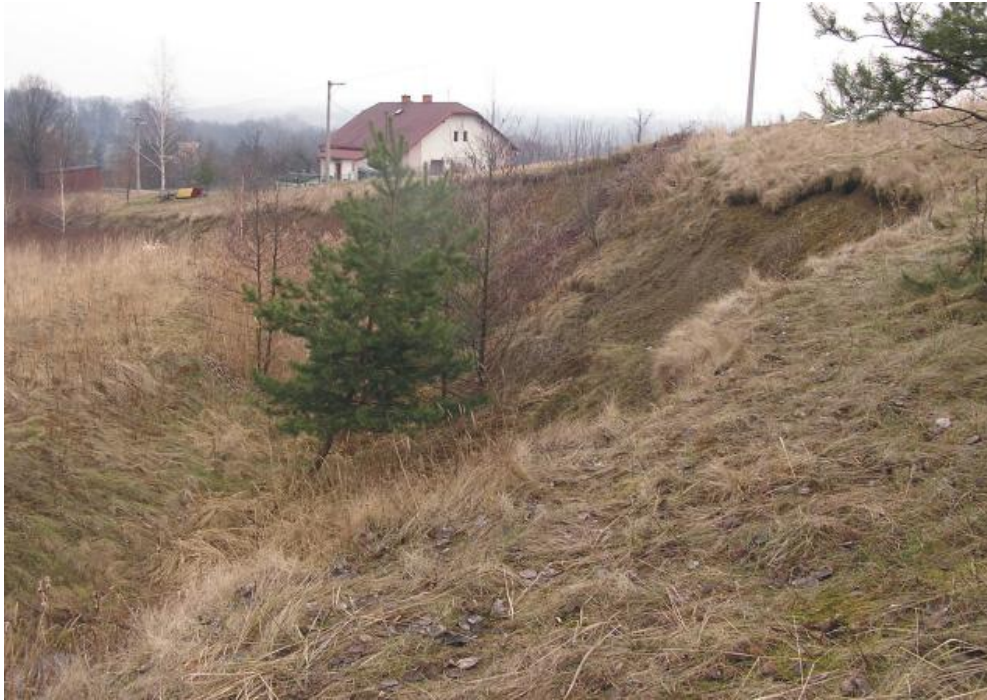
The results of field mapping are in Figure 2. The tear edge of the slide is pronounced, it reaches as high as 8 m (Figure 3) and spreads in the direction southwest-northeast. Due to heavy rainfall towards the end of the

Figure 3. Top tear edge.

The deeper slip surface connects to the tear edge, which is 8 m high in the place of the section and it continues in the depth of 8 to 10 m after the stationing 224 m, where it rises to the surface. It is the case of a slip surface which is again placed on positions with lower or higher values of impedance. Due to the impact of material shifts on this slip surface there are frequent cross and longitudinal cracks and the local road is often broken and lifted. These elements were localized based on significant minimums in the resistive model and

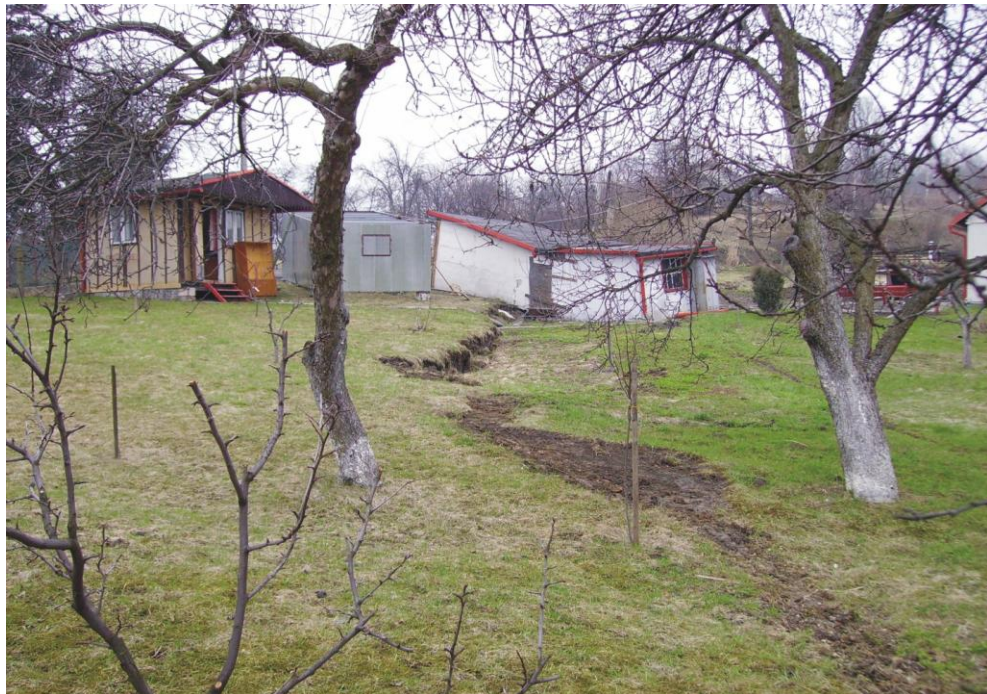
Figure 4. Recent movements on the side tear edge and a tilted tree.

winter and probably in concurrence with undermining impact, there was a significant movement in the central part of the slide. On the tear edge, two new movements appeared up to 0.5 m long (Figure 4). The road connect

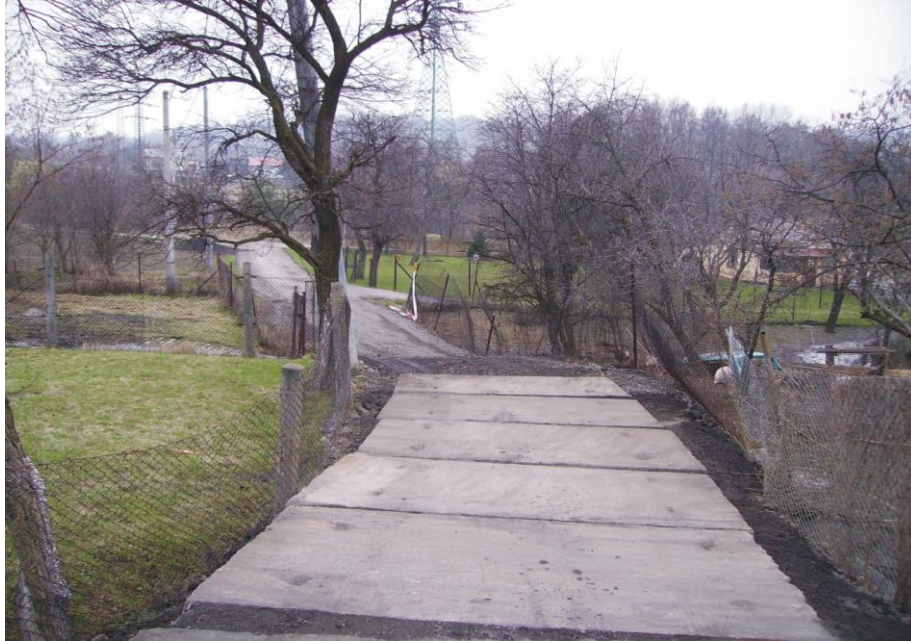
the southeastern and northwestern part of the slide, runs almost perpendicular to the side tear edge. It was disrupted by those movements to such an extent repair by means of panels to maintain its capacity (Figure 5).

Figure 5. Disrupted road.

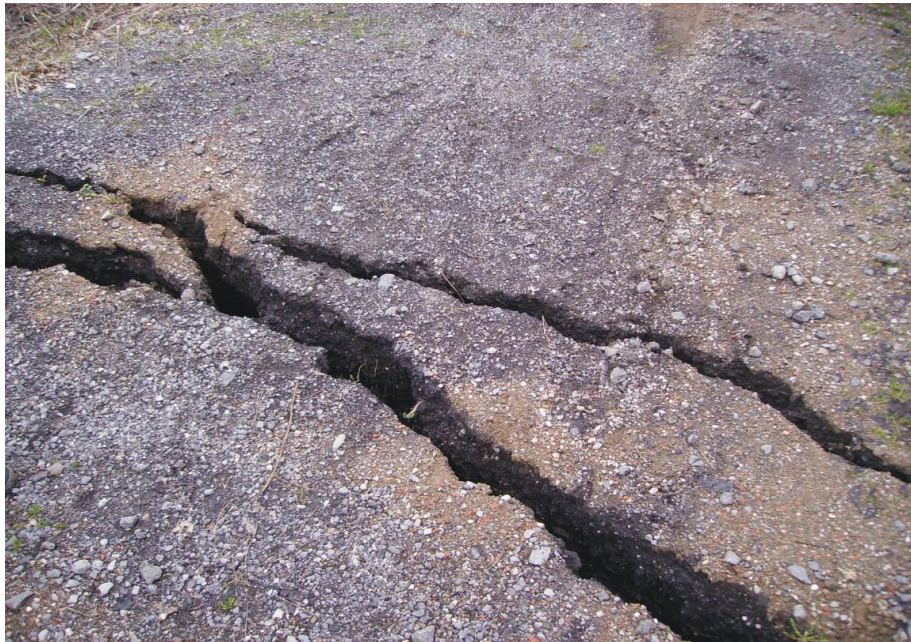
Figure 6. New cracks up to 10 cm wide and 90 cm deep.

The second road runs through the slide section and connects the local part of Kotlina to Šimíčkova Colony and it is not open to motor vehicles any longer. The slide was pushed itself under the road and therefore lifted it and broke it. New cracks with a width of up to 10 cm in a depth of 90 cm occurred across the whole road (Figure

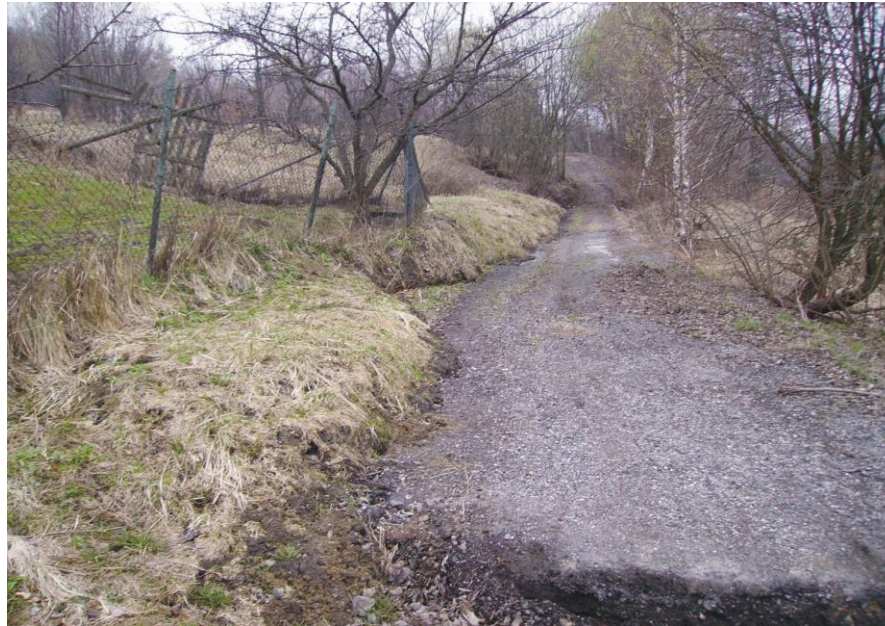
The top soil slumped directly down the road and made it narrower, such that, it was only 1.5 m in wide in contrast to the original 3 m (Figure 7). In the central part of the slide there was a noticeable system of cracks running along the tear edge. In the southwestern part of

Figure 7. Narrowing of the local road due to sliding of the topsoil.

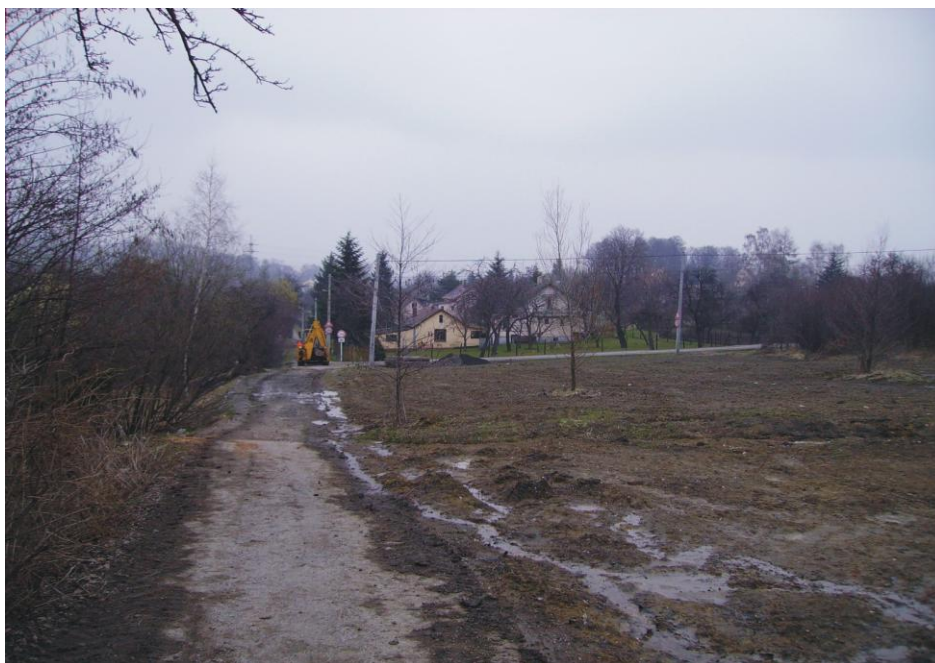
Figure 8. Executed ground shaping.

the slide, the manifestation of sliding gradually lost and became unclear. In the northeastern part of the slide, ground shaping was carried out as a result of reconstruction of water pipeline (Figure 8). In the whole slide there were several areas that are heavily saturated, which also contributes to a decrease in stability.

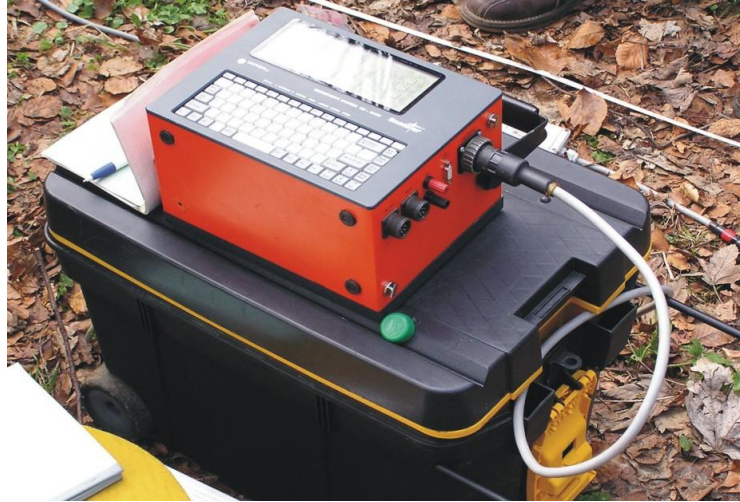
Figure 9. ResiStar device.

tomography was applied at Doubrava Vrchovec landslide. This method combines an advantage of either resistivity profiling or sounding and allows obtaining 2D conception of resistivity condition at measured rock environment.

Resistivity tomography measuring was performed by the usage of electrode system. Electrodes were earthed into the rock environment. They were subsequently switched on either current (A, B) or potential (M, N) electrode during the measurement controlled by the computer. Current electrodes conduit an electric current into the rock environment; potential difference is measured between potential electrodes. ResiStar device (Figure 9) allows an electrode connecting as symmetrical four-electrode Wenner and Schlumberger configuration. Apparent resistivity of rock environment is established from measured intensity of current I (mA), voltage potential difference U (mV) measured between two electrodes; and configuration constant that depend on electrode spacing:

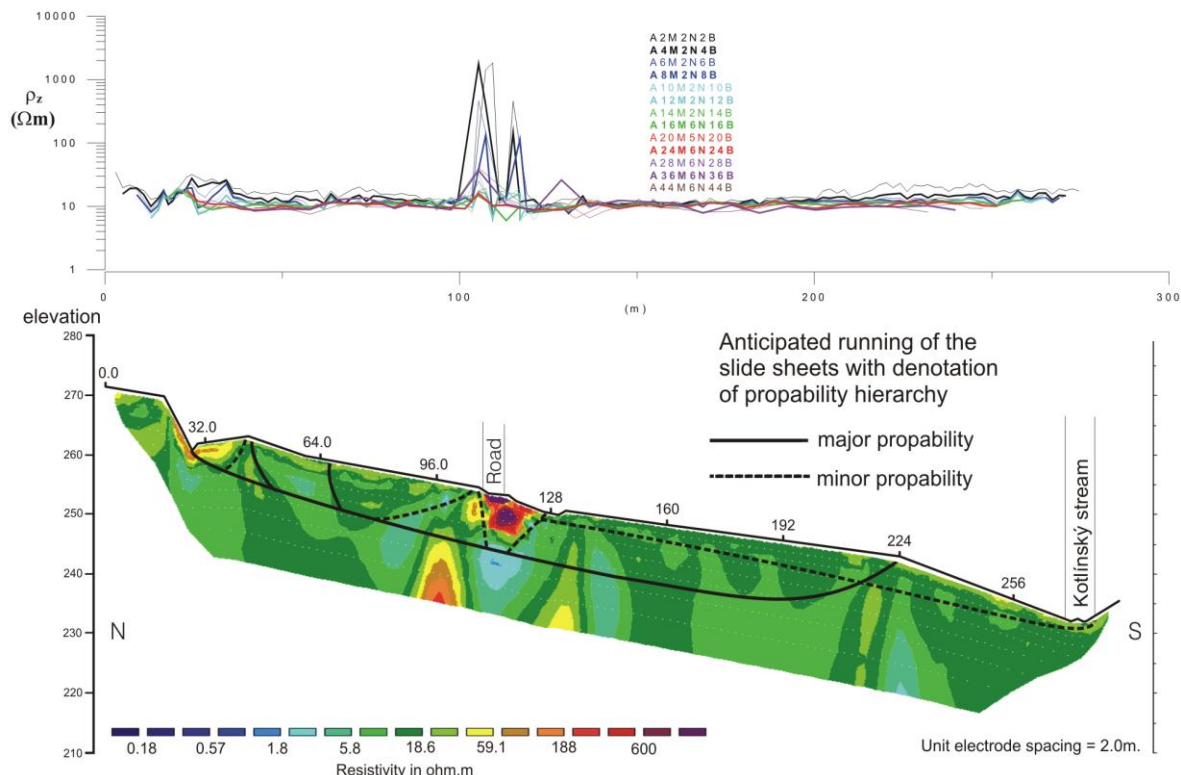
In the locality, a 286 m geophysical section V1 was measured (144 electrodes, pace survey 2 m). The first part was 110 m southnorth and of 340° azimuth. After 110 m (on an impassable road) the section broke more to the north with azimuth 352°. The beginning of the section is situated 14 m above the main tear edge and the end was 10 m behind the Kotlinský Stream. The position of the section is marked on a purpose situation (Figure 2). Figure 10 shows results of resistivity interpretation

Figure 10. Interpretation of resistivity measurement results—profile V1.

(including topography data) of geophysical profile. Course of interpreted sliding surfaces is also drawn in.

The V1 section interpretation is characterized by 2 levels of slip surfaces. The more shallow slip surface with maximum depth of 2.5 to 5 m starts under the disturbed road on the stationing 126 m and continues to the Kotlínský Stream as far as 176 m from the beginning of the section. This slip surface is situated in the positions of local maximums and minimums. In terms of lithology, in the initial part it is the case of a boundary plane between sliding material and Miocene clays or claystone. The end of this slip surface is already found in fine sliding sediments.
